USASC TECHNICAL REPORT  
TR 79-2  
APRIL 1979

# **CRASH SURVIVAL EVALUATION OF THE RU-21B**

PREPARED BY THE U.S. ARMY SAFETY CENTER, FORT RUCKER, ALABAMA

**CRASH SURVIVAL EVALUATION  
OF THE RU-21B**

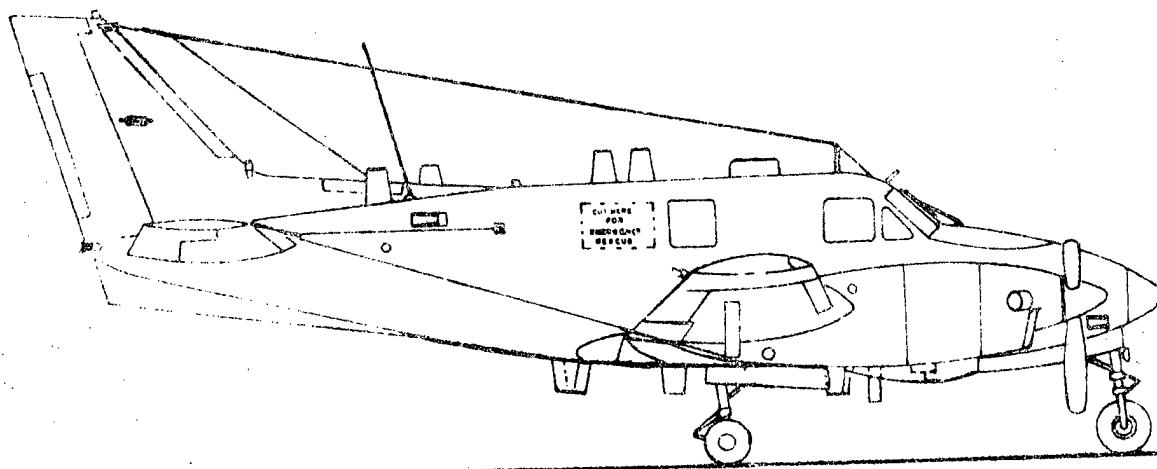
FIGURE 3

The aircraft has numerous antennae located on the bottom and top of the main fuselage (See Figure 3). The lower antennae are highly susceptible to crash damage with resulting arcing near areas of anticipated fuel spillage.

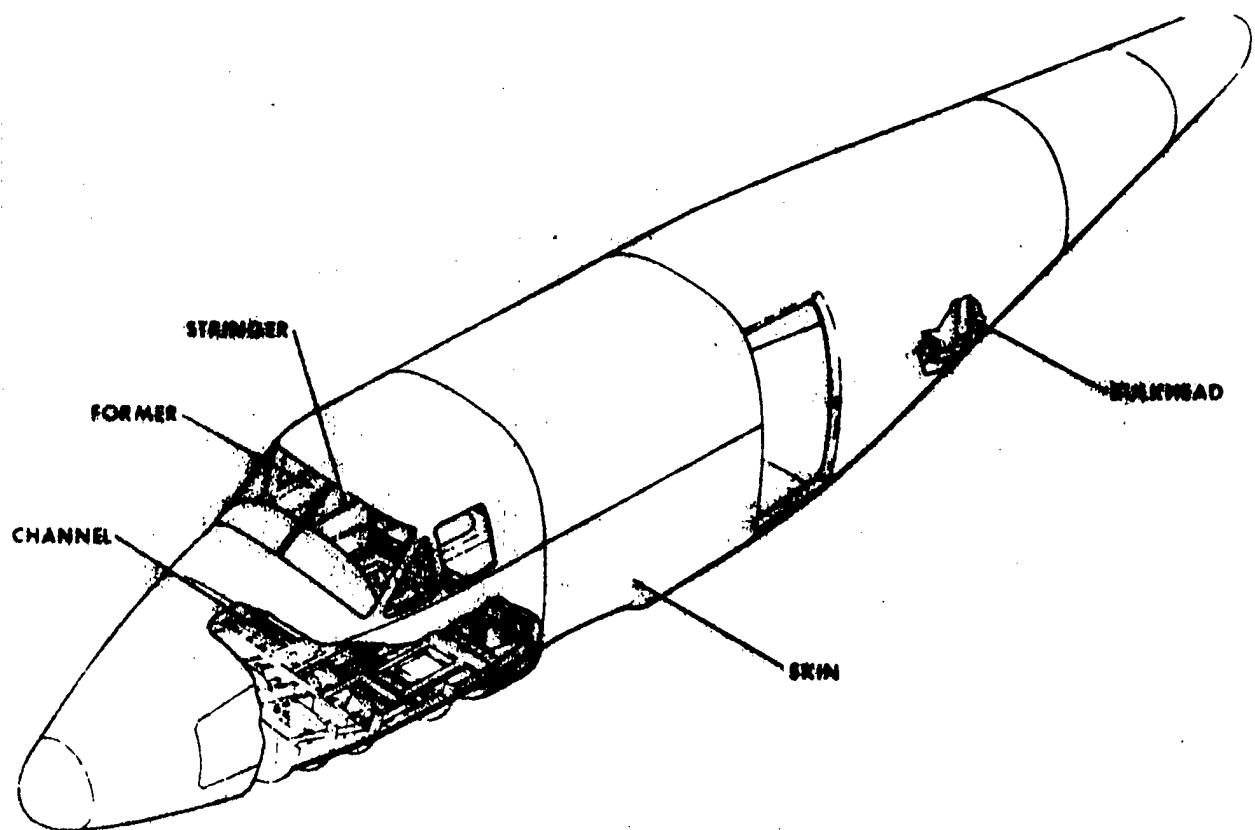
FIGURE 4 -Basic Fuselage Structure

Views of the RU-21B aircraft are shown in Figures 1-3. These views show the cabin entry door, rescue openings, antennae locations, landing gear and overall configurations. The basic fuselage structure is illustrated in Figure 4. The crew seating and cabin configuration is shown in Figure 5.

As noted above the fuselage is a semi-monocoque construction consisting of aluminum bulkheads and sheet metal formers and stringers. These and the keel beams in the floor should prevent the floor from buckling in a moderate crash. Resistance to roof collapse is provided by the curved roof members, stringers, and additional longeron above and below the windows on either side of the aircraft.

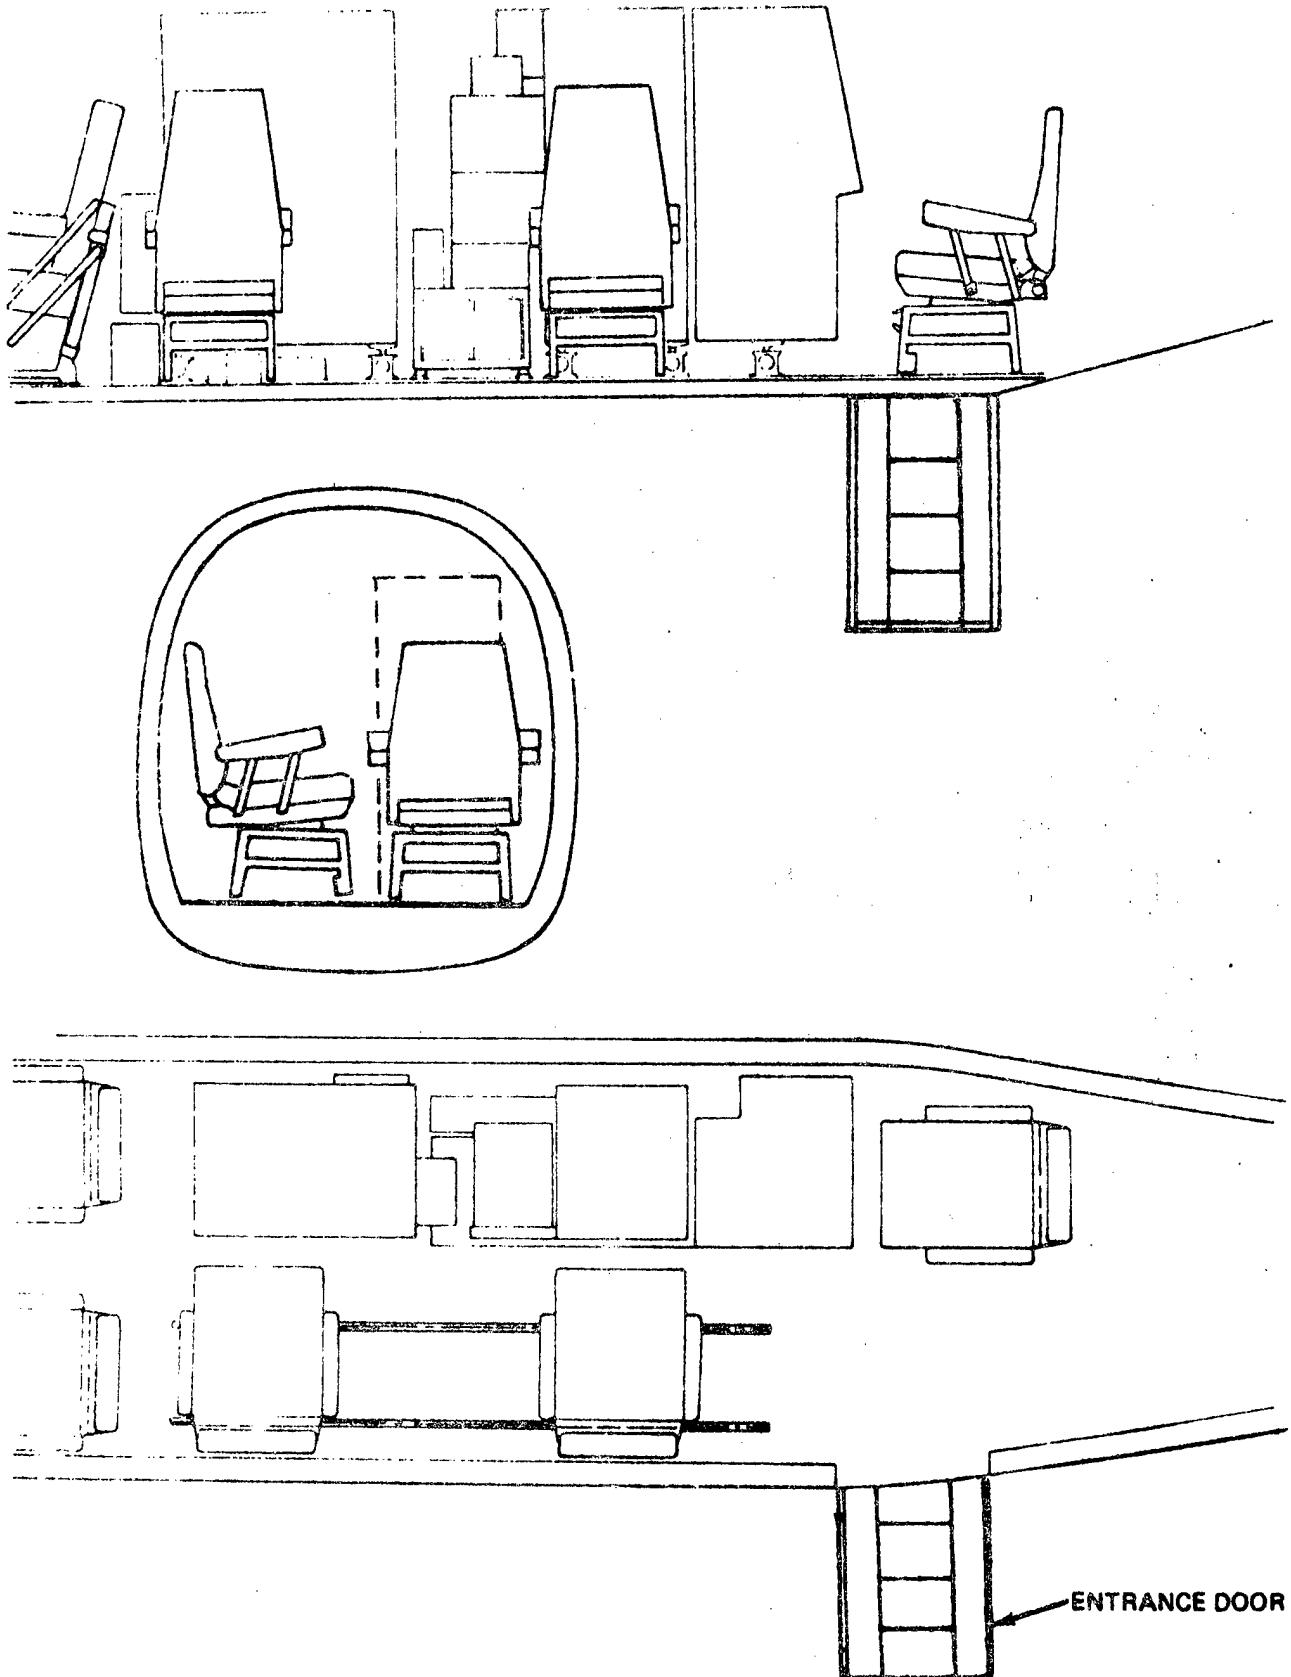
FIGURE 5 -General Interior Arrangement Diagram

The pilot's and copilot's seats of the RU-21B are arranged in a side by side configuration as shown in Figure 5. The seats are adjustable chair type seats having adjustments vertically as well as fore and aft. They are tabular frame construction and attach to a floor mounted rail. The seat bottom and back consists of foam rubber cushions approximately 4" thick. The seat belts attach to two floor disconnect fittings aft of the seats. The shoulder harnesses attach to a roof mounted inertia reel to provide crash restraint. See Figure 6. The reel will lock automatically under a 2 'G' impact or may be manually locked. Seat design is assumed to conform to Reference 2.

Three mission operators seats are mounted in the aft cabin area as shown in Figure 5. A view of the seat is shown in Figure 7. The seats are mounted on tracks near the mission consoles and may be swiveled to allow the operators to face forward, inboard, or aft. The lap belts attach to the seat. No shoulder harness is provided. The seat is assumed to have been designed to Reference 2.

The main cabin door located in the rear of the fuselage (Figure 5) is used for normal or emergency exit. The door is simple to open requiring only a turning motion of the internal or external handle. A removable window is located on the right side of the cabin section but is blocked by mission equipment. Should the main door be blocked or jammed, exit can only be accomplished by breaking out the windshield or cutting a hole in the fuselage at the location shown in Figure 15. Evacuation of the aircraft is greatly handicapped by the internal configuration of the aircraft (Figures 16,17,18). The pilot, copilot, and mission crew members in the forward portion of the cabin have to climb/crawl over seats and/or occupants to exit the aircraft.

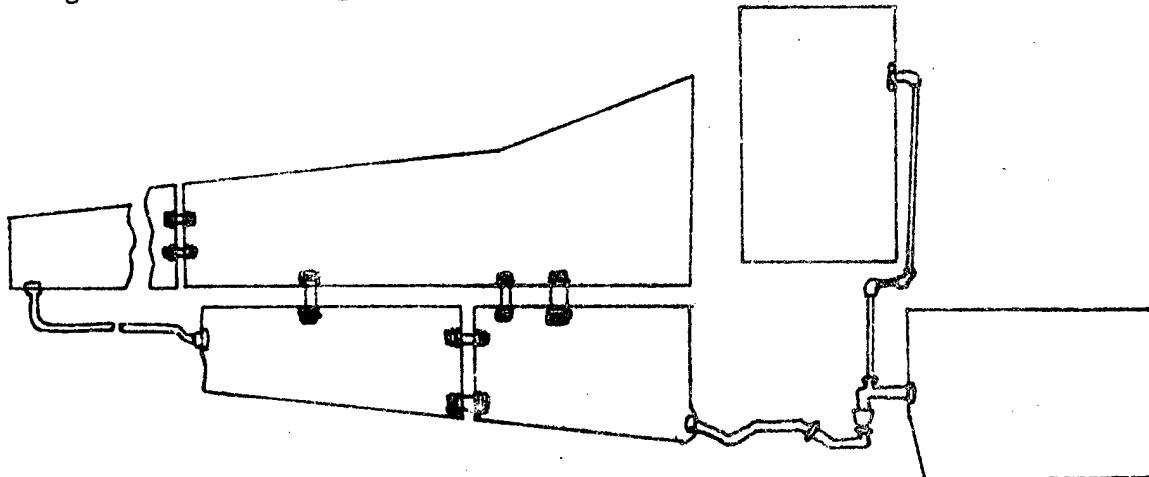
**FIGURE 9 -RU-21B Fuel Containment System (Some interconnecting lines removed for clarity.)**

Because of their location in the wings, the tanks are highly susceptible to damage/rupture/puncture in a crash, especially in rough terrain.

The fuel tanks located in the wings are highly susceptible to crash damage. Many locations such as the filler areas, fuel quantity indicators and vents are rigidly attached to the wing structure and the fuel tank. The tanks are connected by metal coupling. Any deformation in an accident can result in the fittings being torn from the tanks and fuel spillage.

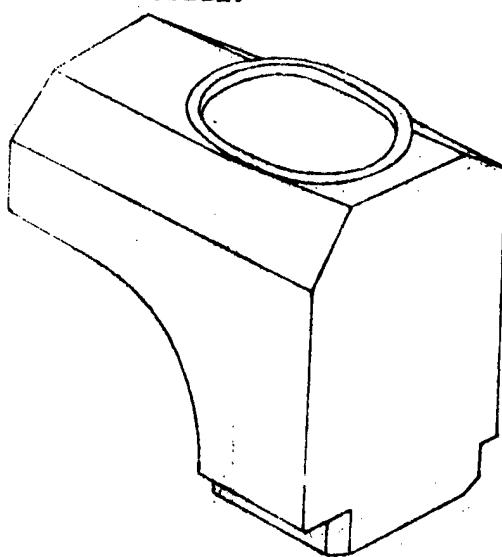
FIGURE 12 -Nacelle Tank Configuration.

The nacelle tank being located behind the engine and above the wheel will result in a tank configuration as shown in Figure 12. The wing tanks are essentially flat with square corners, no irregularities. The nacelle is constructed of a self-seating (bullet-proof) material and the wing-mounted tanks are constructed of rubberized material.
